## The importance of imaging methods in catheter dysfunction: Two rare cases and their management

Ersin Çelik<sup>1</sup>, Ahmet Çora<sup>1</sup>, Kadir Burhan Karadem<sup>2</sup>

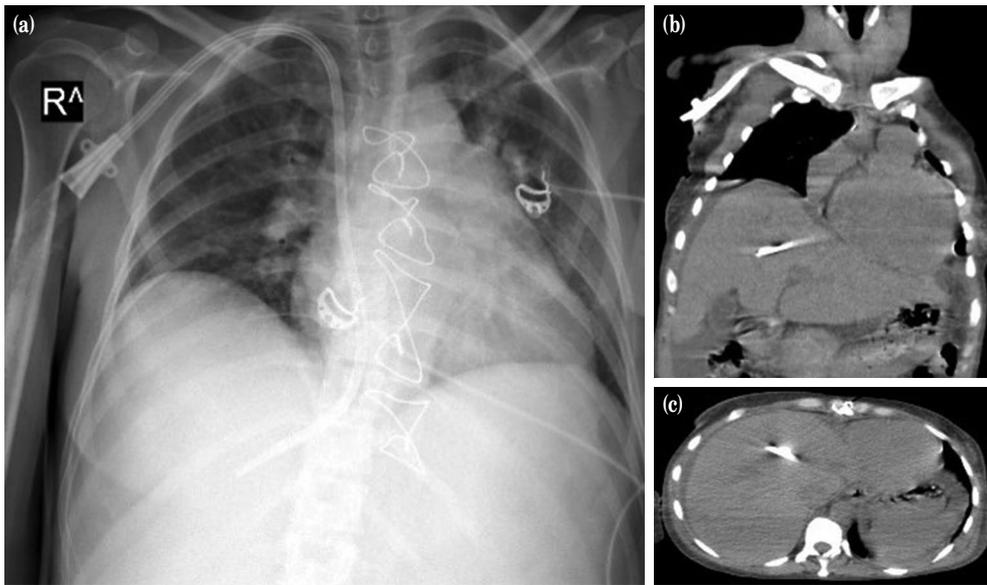
week for several years was consulted. The patient had many failed operations in both upper extremities with the purpose of creating a vascular access point. Her medical history revealed the placement of a cuffed-tunneled hemodialysis catheter (14.5-Fr, 32-cm; Palindrome Chronic Catheter, Covidien AG, Dublin, Ireland) into the right internal jugular vein (IJV), which was applied by another surgeon in an external clinic without fluoroscopy due to the lack of peripheral access approximately a week ago. The patient had no clinical complaints; however, despite dialysis for three days a week, serum creatine, alanine aminotransferase (ALT), and aspartate aminotransferase (AST) levels were found to be elevated. Based on the chest X-ray and thoracic computed tomography (CT) imaging, malposition of the catheter tip to the middle hepatic vein was detected (Figure 1).

**Figure 1.** Malposition of the cuffed-tunneled hemodialysis catheter. (a) View of catheter malposition on chest X-ray. (b, c) View of catheter malposition into the middle hepatic vein on computed tomography.

The right innominate vein, azygos vein, and internal thoracic vein are the most reported locations for malposition. Malposition can be seen as a result of selecting a too long catheter or inserting it too far into venous area, which is particularly more frequent when the operator does not use fluoroscopy. It can be also seen as a result of migration via inspiration-expiration movements or heart beats. Malposition of the cuffed-tunneled catheter into the hepatic vein as in the first case has rarely been reported in the literature.<sup>[2,5]</sup>

vein, the lack of sufficient flow from the catheter and insufficient dialysis therapy can be observed, and chest pain or abdominal discomfort or pain may be seen as the manifestations in these patients.<sup>[2,5]</sup> Also, hepatic vein injury and, after injury, a life-threatening complication such as hepatic vein thrombosis can be seen as a complication of this malposition.<sup>[5]</sup> In the first case, only the lack of catheter flow on dialysis, insufficient hemodialysis and elevated AST and ALT levels were evaluated. After an immediate insertion of a new catheter into a suitable position, the patient's laboratory tests recovered rapidly and uneventfully. Either there is hemodialysis insufficiency or not, in the presence of elevated liver enzymes and atypical chest findings or abdominal pain occurred after placement of a dialysis catheter, malposition of the catheter into the hepatic vein must be kept in mind, as well as the other causes that could result in catheter dysfunction.

Under the guidance of fluoroscopy, the catheter was replaced with a shorter one (14.5-Fr, 28-cm; Palindrome Chronic Catheter, Covidien AG, Dublin, Ireland). On fluoroscopy, the placement of the catheter tip was confirmed, as it was in the right

atrium. The placement of the catheter tip and possible pneumothorax were controlled with chest X-ray. The patient went on the hemodialysis therapy uneventfully and, after the operation, a progressive decline in the biochemical parameters was observed.

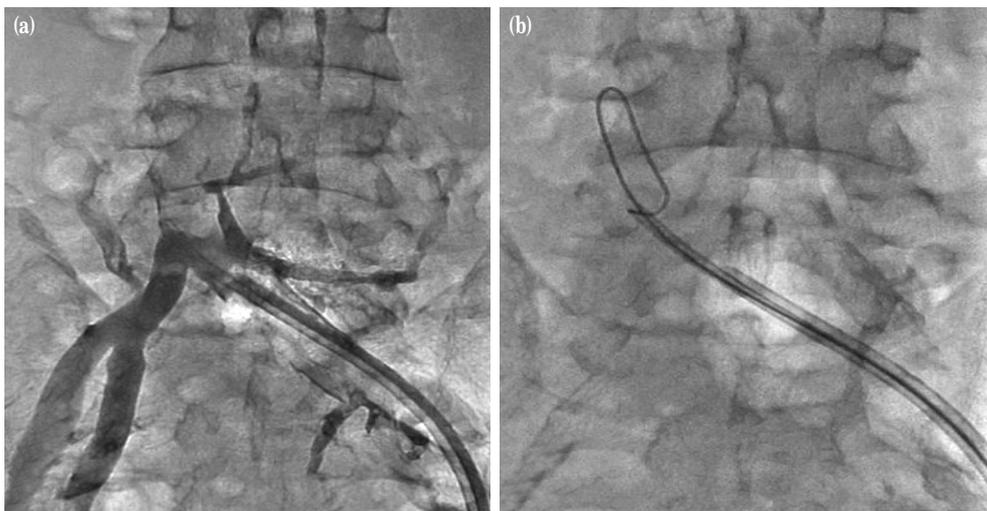
**Figure 2.** Thrombosis of distal inferior vena cava. (a) Inferior vena cavography. (b) Non-advance hydrophilic guide wire.

FV. On the final hemodialysis treatment, the patient was evaluated regarding inadequate flow from both lumens of the new catheter. Venography was performed via the left femoral tunneled catheter to determine the problem, and total thrombosis just proximal to iliac bifurcation was observed (Figure 2a). After failing an attempt to pass the occluded part through the IVC by a hydrophilic guidewire, the intervention for IVC thrombosis was terminated (Figure 2b). For generalized ecchymosis and hematoma on the right side of the neck, left IJV puncture was performed under the ultrasonographic guidance. Fluoroscopic imaging was made via a puncture needle and no occlusion was detected on the left IJV, brachiocephalic vein, or VCS (Figure 3a). A cuffed-tunneled hemodialysis catheter 14.5-Fr, 32-cm; Palindrome Chronic Catheter, Covidien AG, Dublin, Ireland) was placed with fluoroscopy guidance (Figure 3b).

The cuffed-tunneled catheters are made of silicon or polyurethane materials. These materials reduce thrombogenicity and endothelial damage. As in our second case, they may cause thrombosis, even in the largest veins in terms of diameter. Although thrombosis or vascular damage is rarely seen even in misplaced dialysis catheters, symptoms or complications can develop depending on where the catheter is positioned after the insertion. As in the first case, due to the malposition into the hepatic

As in our second case, venography can be done via a present hemodialysis catheter to determine the problems such as pericatheter sleeve, thrombus formation or central venous occlusion, before changing the dysfunctional catheter.<sup>[6]</sup> By applying the venography, we determined the IVC occlusion and we avoided multiple punctures to IVC. Additionally, venography via IJV puncture and determining the persistence of the left IJV and vena cava inferior, we apply the guidewire and place the cuffed-tunneled catheter to the left IJV safely without any complication.

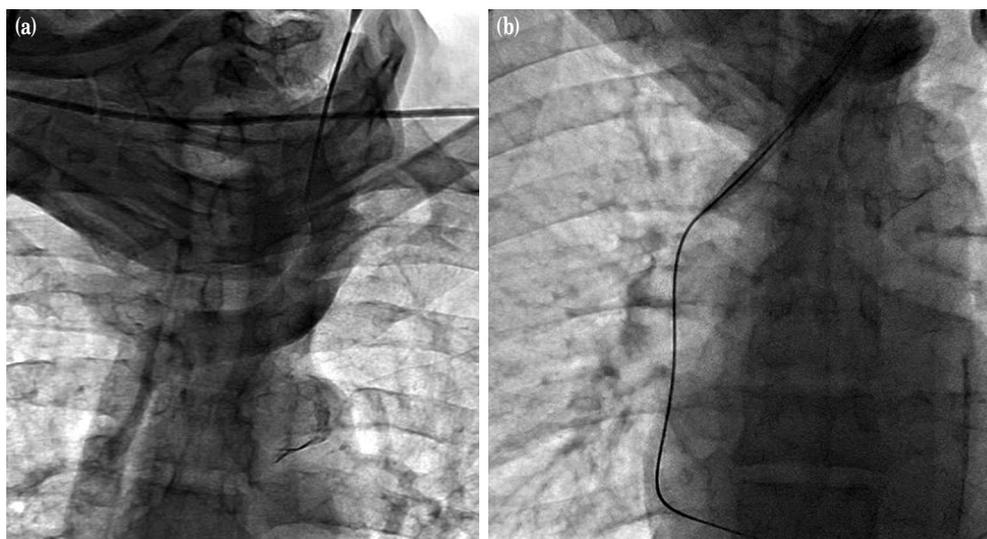
**Figure 3.** (a) Venography from the left internal jugular vein (b) view of guidewire and cuffed-tunneled catheter
