Removal of the splitted guidewire forgotten during the treatment of varicose veins via radiofrequency ablation

Mehmet Işık

Department of Cardiovascular Surgery, Necmettin Erbakan University Meram Faculty of Medicine, Konya, Turkey

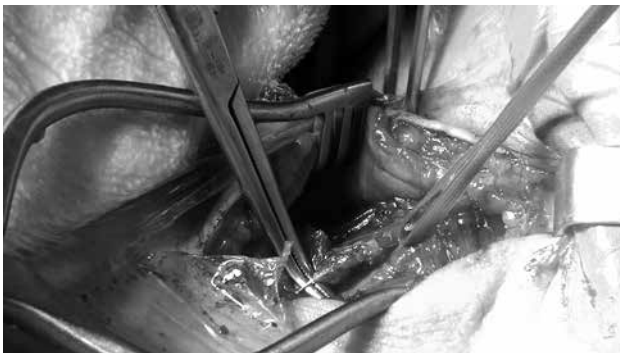
Figure 2. Removal of extravasated hard wire by right jugular vein exploration.

anterior side of the right sternocleidomastoid muscle and mastoid process-clavicle midline. It was observed that the hard wire was extravasated 2-cm toward to the posterior. The wire was released and removed between the muscles (Figure 2). Although the exploration toward the clavicle was continued, the second wire was unable to be reached. Therefore, right femoral vein percutaneous catheterization was applied from the inguinal region. Under the guidance of C-arm fluoroscopy, a catch wire was sent, and the second wire was caught in the right atrium and removed from the femoral vein (Figure 3). Examination of the retrieved wires showed that the carrier rough wire, which was broken into two components, and the elastic helical wire sections wrapped on it were separated from each other. After surgery, echocardiography and complete blood count were performed. The patient

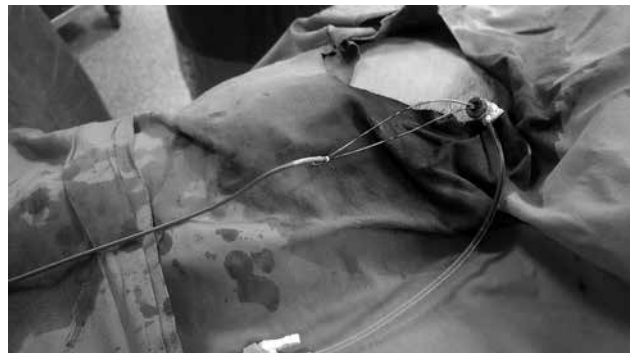
Figure 3. Removal of the second wire, caught in right atrium, from femoral vein.
